GAP ANALYSIS FOR DEPARTMENT OF PUBLIC WORKS, NEW MILFORD, CT

Prepared for Brownfield Practicum

May 10th, 2021

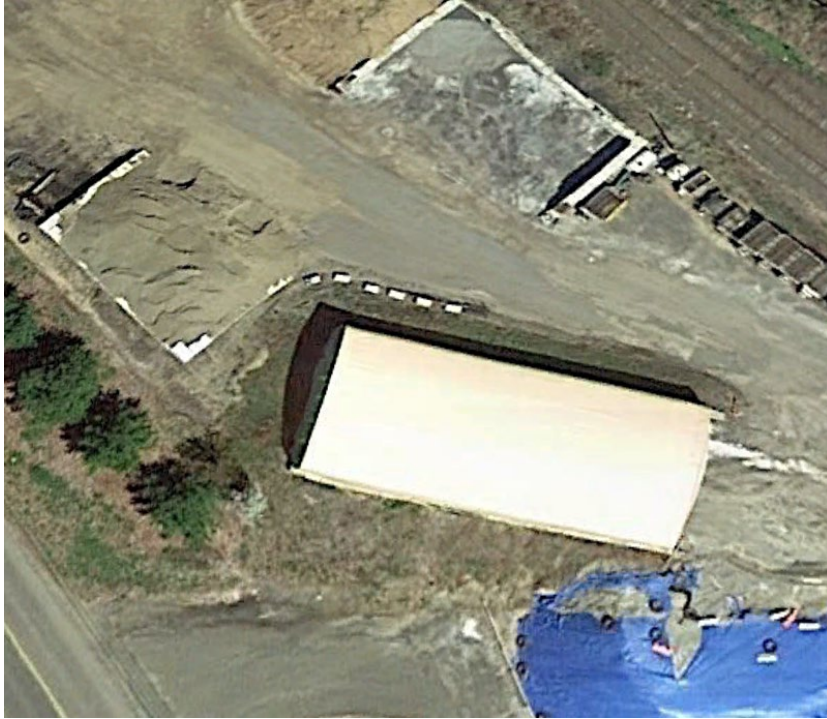
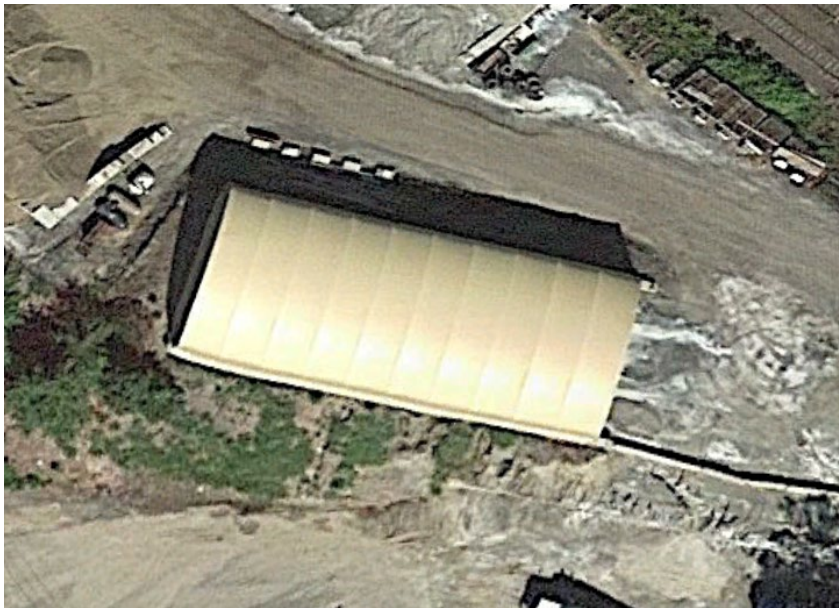
AOC-5: based on Google Earth images, the discarded tanks behind the storage canopy were placed sometime between 2016 and 2017. It is unknown whether the tanks are empty and what their origin is.

Image 4. Google Earth view of area behind canopy on 20 YFR in 2016 (top) and 2017 (bottom)

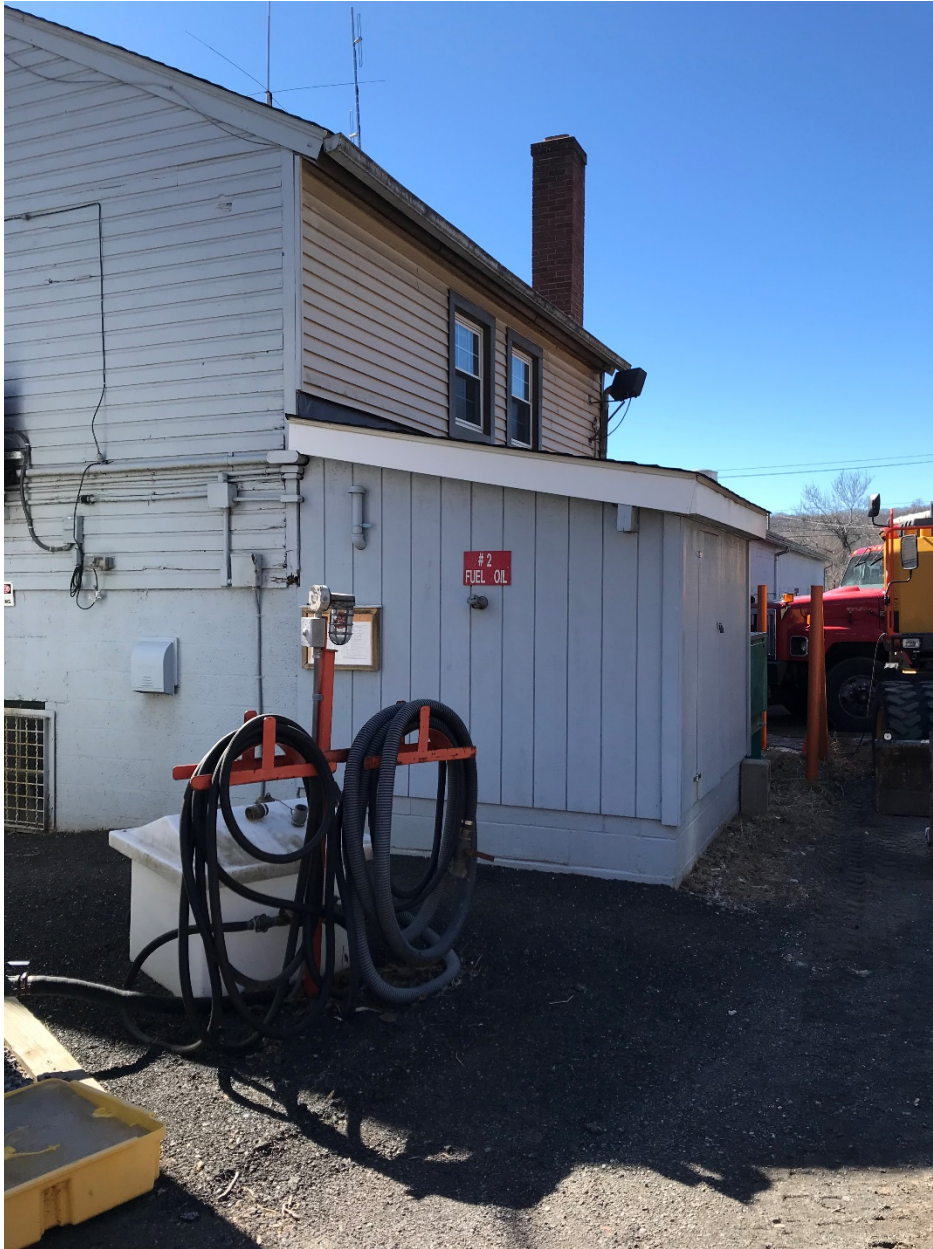
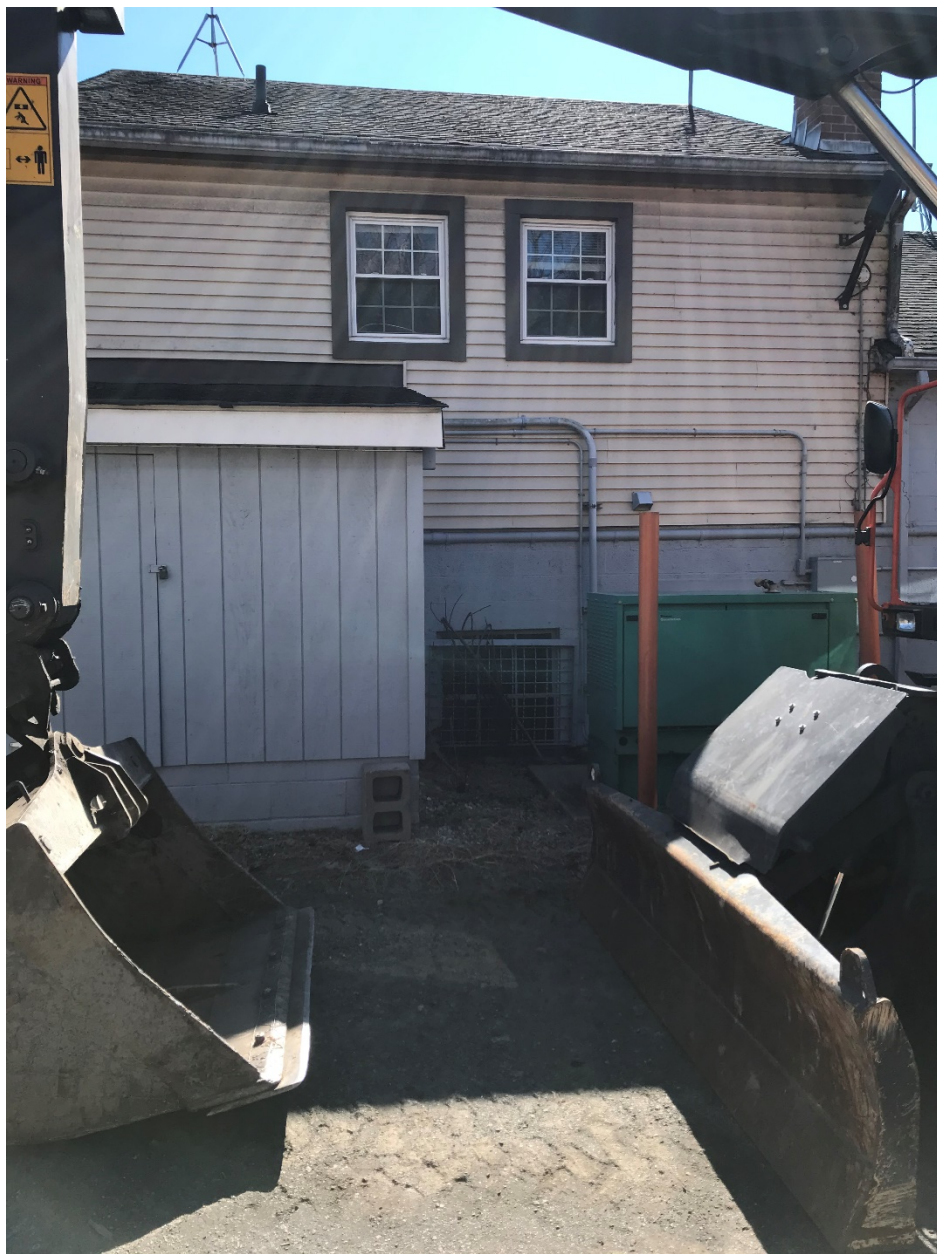
AOC-2: The area behind Building 1 where the passive venting system was located; according to the 2014 ESA report, contaminated soil was left in place after UST removal, and an AST is now located inside a shed.

The soil venting system was covered by the existing shed and the zone of residual contaminated soil was not further investigated. The existence of residual contaminated soil in the UST grave has to be investigated.

Photograph 1: View of AOC-2 on 6 YFR, looking towards the east

Photograph 2: View of AOC-2 on 6 YFR, looking towards the south

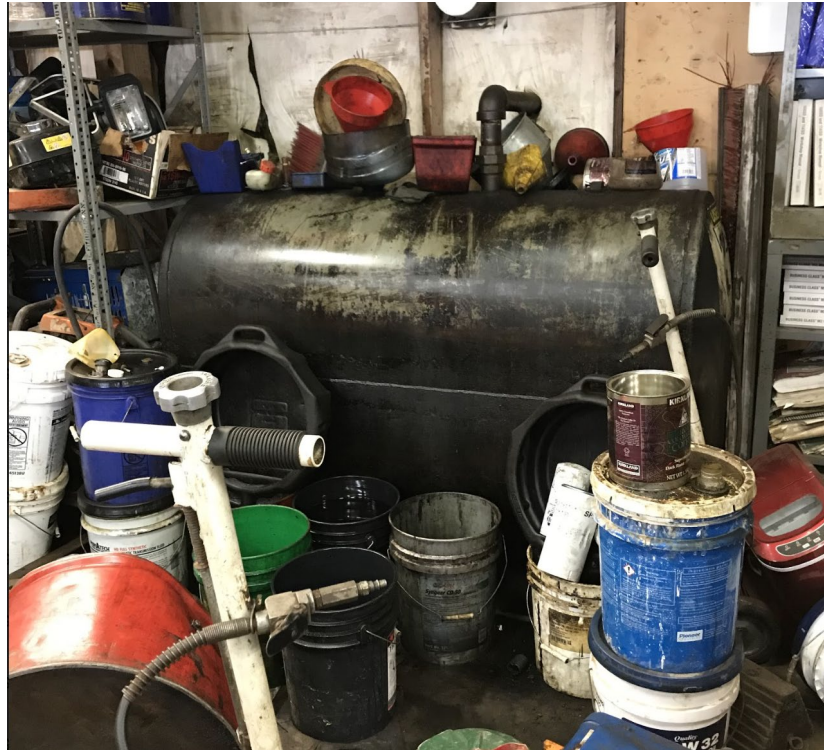
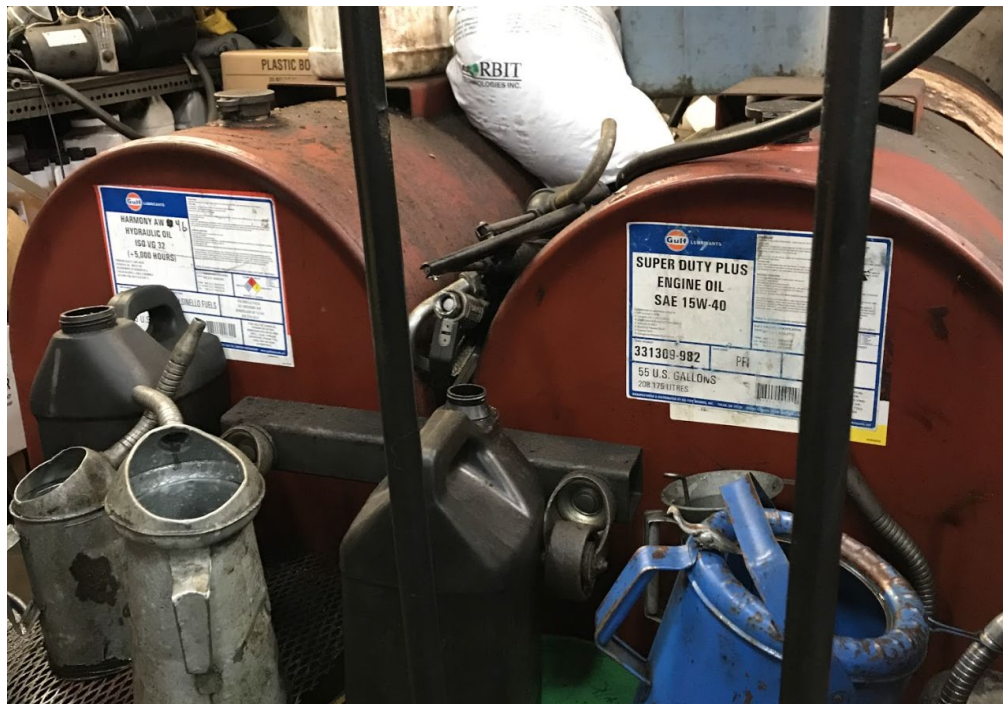
AOC-4: Several areas in the interior of each building, where hazardous material such as fuel and motor oil was stored and handled.

Photograph 3&4: ASTs containing Waste oil, AST for virgin motor and hydraulic oil tanks, miscellaneous vehicle maintenance fluid bulk storage, and parts cleaner in 6 Young's Field Road's Building 5.

Building 5: Obtain grab sample(s) in areas with apparent oil staining and test for ETPH and VOCs. Following AST removal a grab sample beneath the fill port where spills may have occurred during filling; testing should be done for ETPH and VOCs. For the former motor field USTs and fueling station east of building 5 it is recommended to perform a soil boring to a depth of at least 15 feet or until no visual or olfactory evidence of potential impact is present. It is recommended to test for ETPH and VOCs.

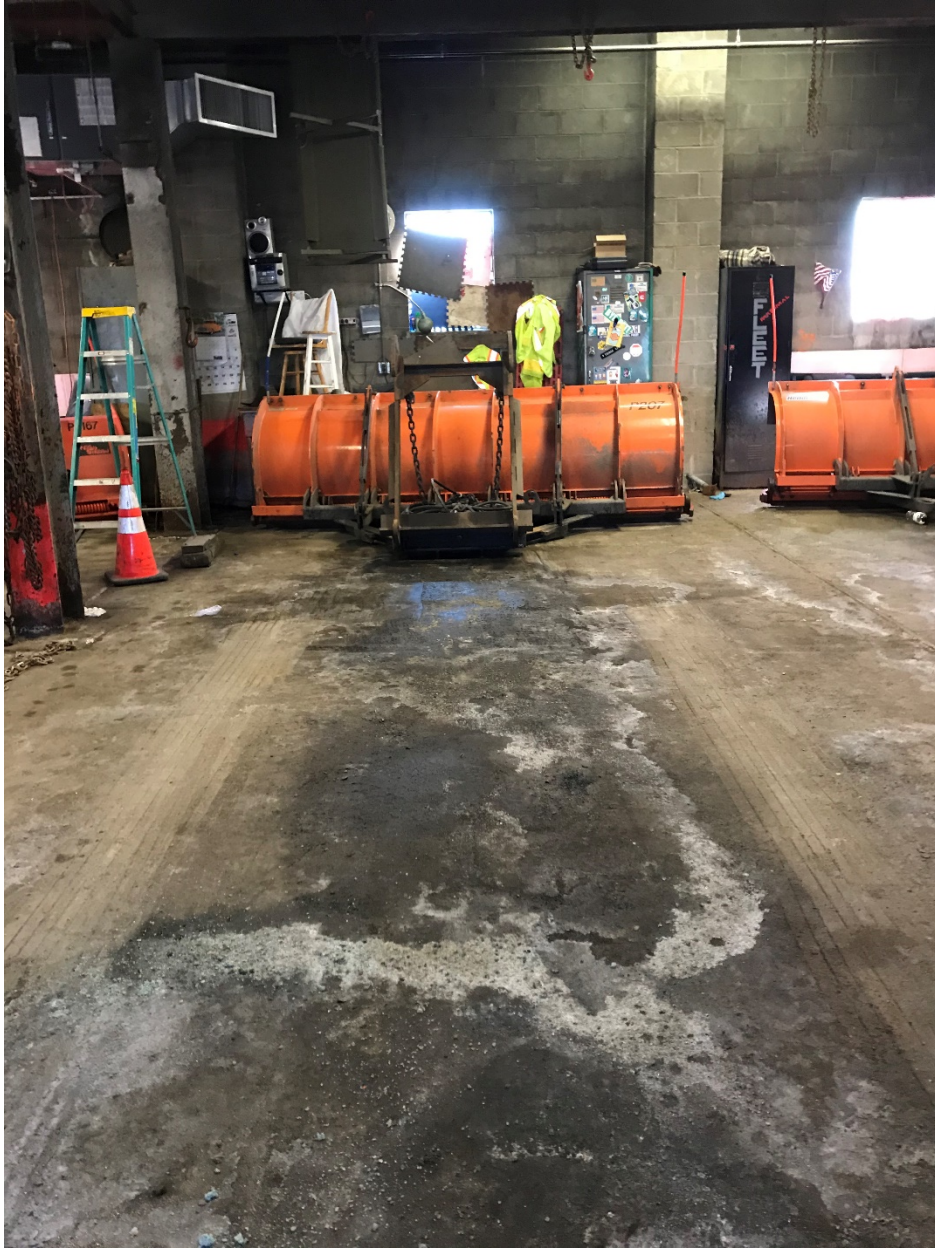
The areas where potential spills could have occurred due to material handling and storage need to be sampled to confirm there has not been any contamination.

Photograph 5: Floor staining in Building 4

Building 4: Obtain grab sample(s) in areas with apparent oil staining and test for ETPH and VOCs.

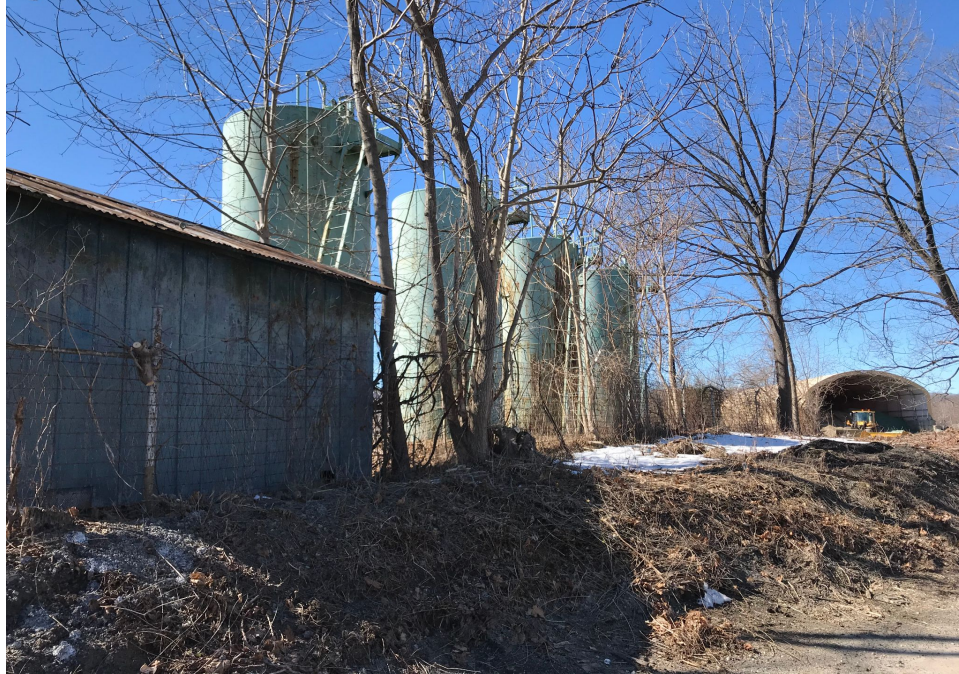
AOC	Description
1	4 tall ASTs on eastern part of the site (Photo 6 and 7)

Given the storage and handling of fuels in AOCs 1 through 9, spills and leaks may have occurred and been sources of soil and groundwater contamination with petroleum hydrocarbons.

Photograph 6. View of 8 Young's Field Road's four ASTs and shed from 11 Railroad Street.

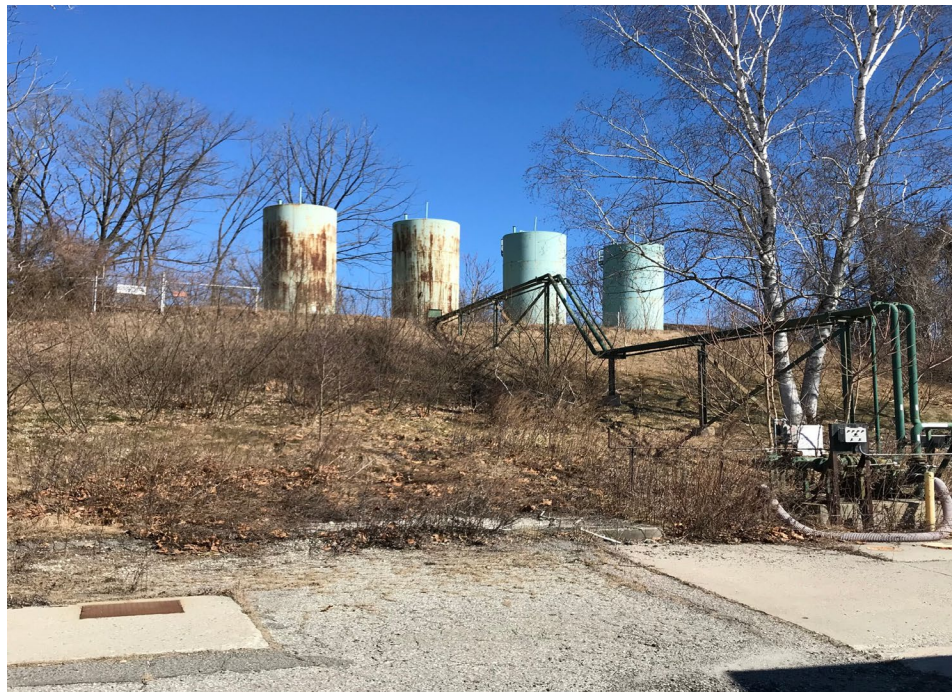
2	Pipes connecting the four ASTs to the filling station (Photo 7)
3	UST- 1 (Photo 8)
4	UST- 2
5	UST- 3 (Photo 8)
6	UST- 4 (Photo 9)
7	Fill Station- 1 (Photo 10)
8	Fill Station- 2 (Photo 9)
9	Canopy Fill station (Photo 11)
10	Storm water drain (Photo 12)

Photograph 7. 8 Young's Field Road's ASTs and pipes connecting them to the western portion of the parcel.

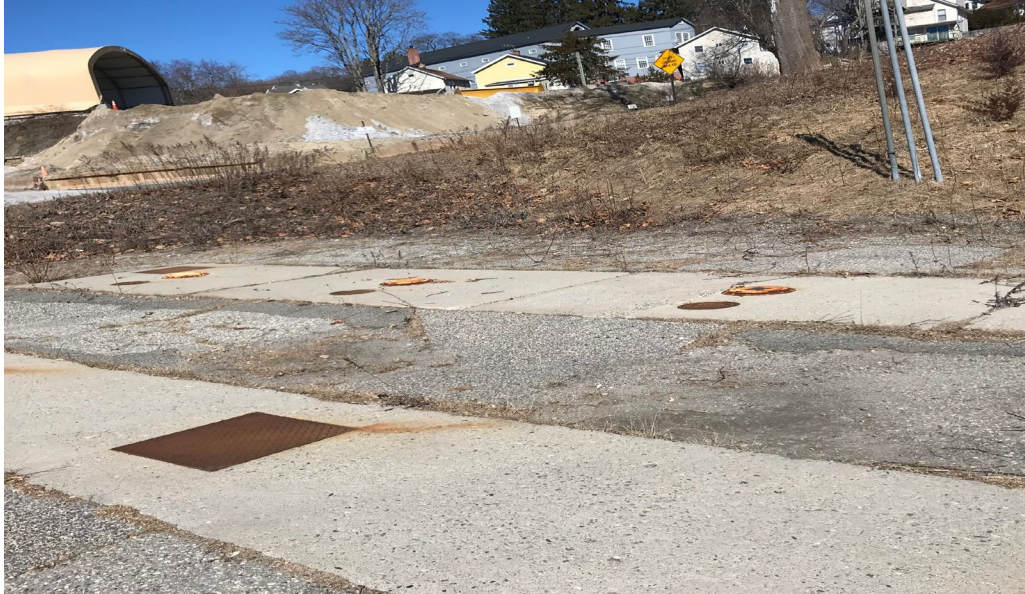
Photograph 8. View of UST- 1 (middle of picture) and partial view of UST- 3 (bottom of picture) on 8 Young's Field Road.

Grab samples will be collected as part of the UST removal process according to the sampling protocols recommended by the CT Department of Energy and Environmental Protection (<https://portal.ct.gov/DEEP/Underground-Storage-Tanks/UST-Closure-Sampling-and-Analytical-Methods>). Samples will be collected from each of the tank's side walls and the soil directly underneath them. Twenty-two grab samples have been recommended for this site (see Figure 3).

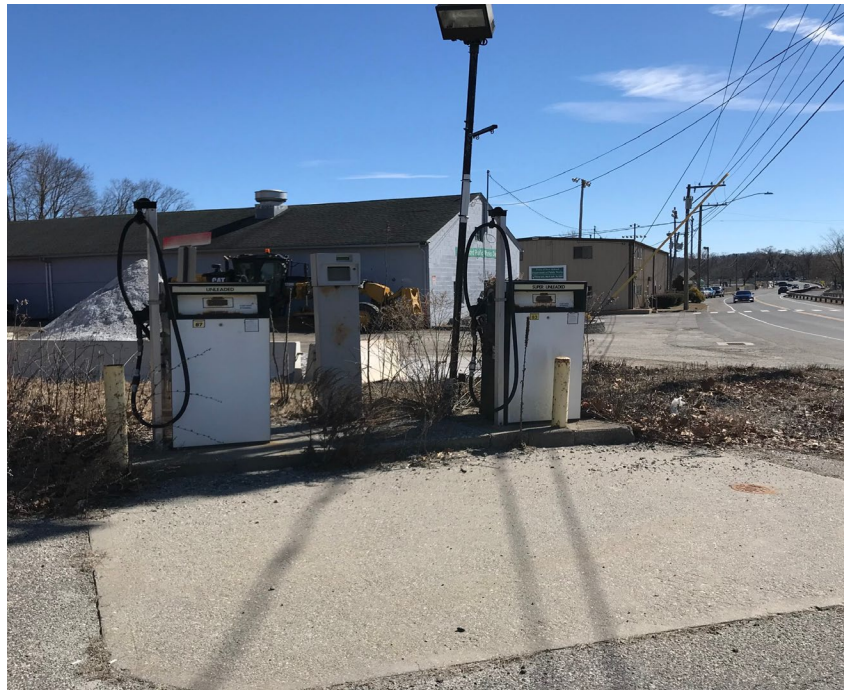
Photograph 9. Gas refueling station and UST- 4 on 8 Young's Field Road (referred to as Fill Station-2 in Figure 3).

There are nine identified locations where soil borings can take place: one underneath each of the three fill stations; one between the central fill station and Young's Field Road; one between the two USTs; two underneath the pipes connecting the four ASTs to the western part of the site; one in the center of the four ASTs; and one up-gradient of the ASTs to ascertain there is no contamination from offsite sources. Three of these soils borings should be combined with new monitoring wells.

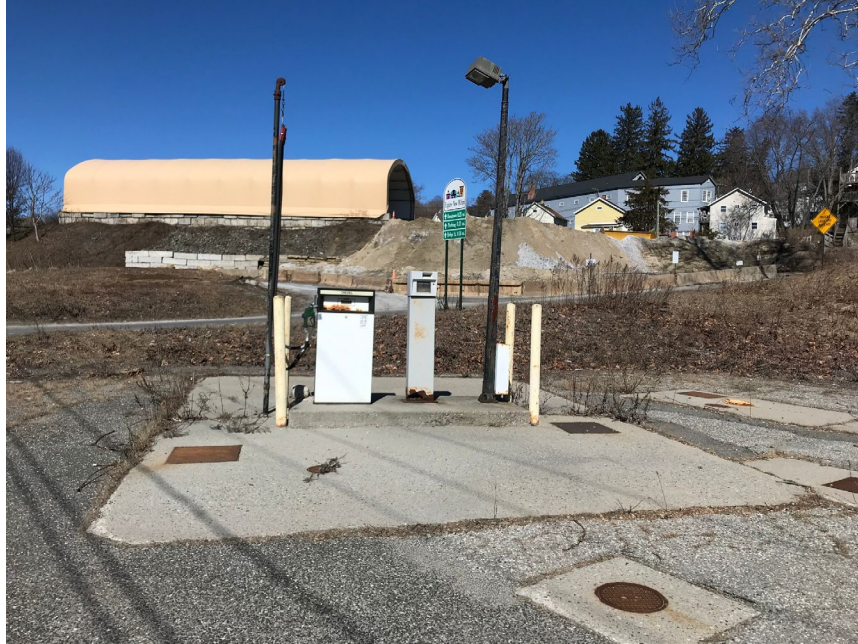
Photograph 10. Diesel refueling station on 8 Young's Field Road (referred to as Fill Station-1 in Figure 3).

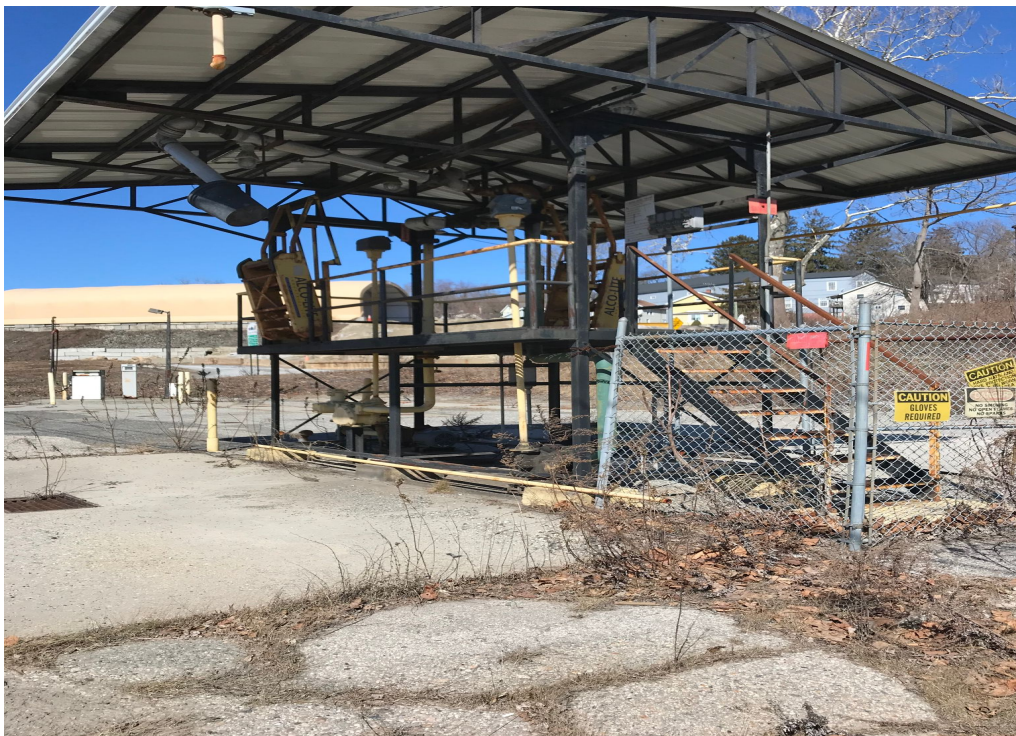
Photograph 11. View of canopy fill station on 8 Young's Field Road.

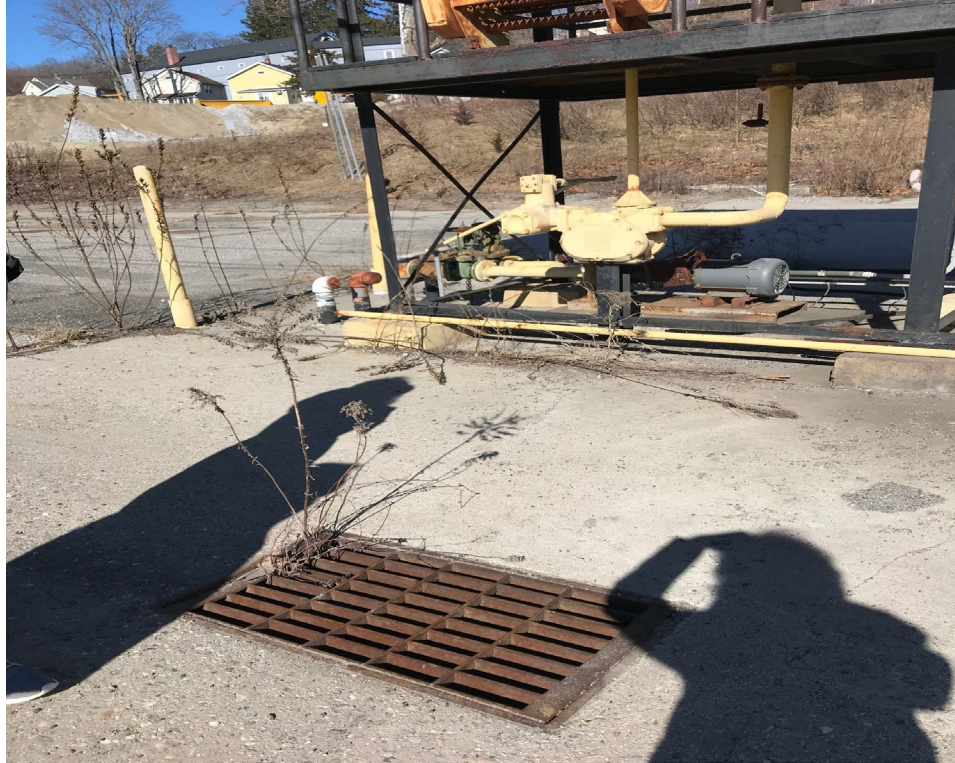
Possible runoff of contaminants from the refueling station's spills and leaks could enter this storm drain, designated as AOC-10.

Photograph 12. Storm drain in front of canopy fill station on 8 Young's Field Road.

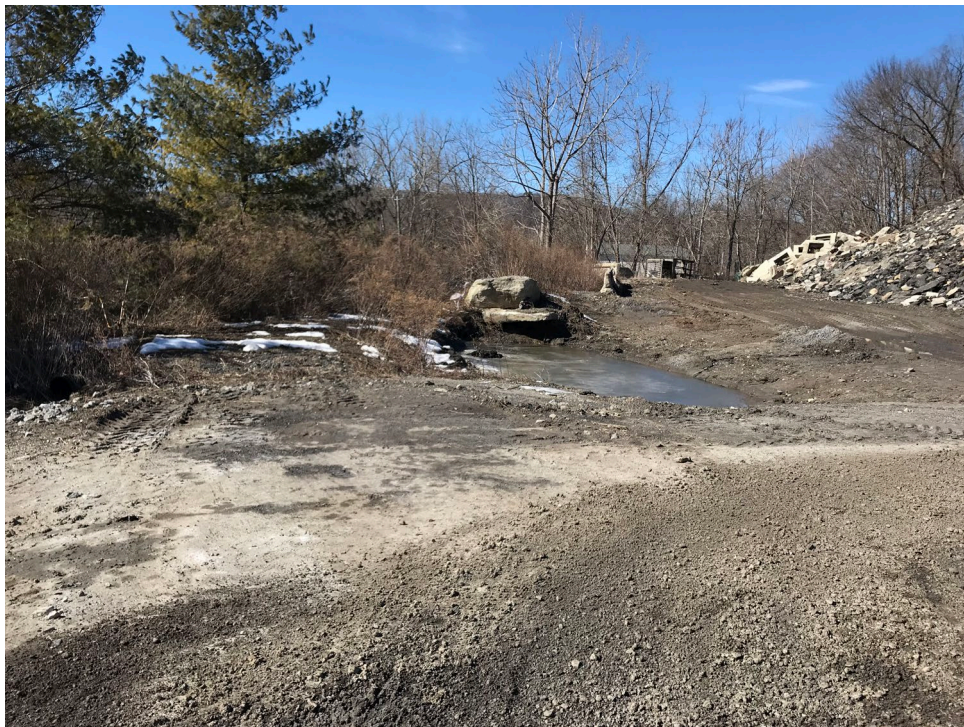
AOC-1: This is an area on the southern portion of the parcel used to dispose of storm water sediment from the catch basin. Sediment is often associated with accumulation of various contaminants.

Photograph 13. Catch basin sediment disposal pit on 20 YFR

AOC-1: take a grab sample of the sediment and test for VOCs and metals.

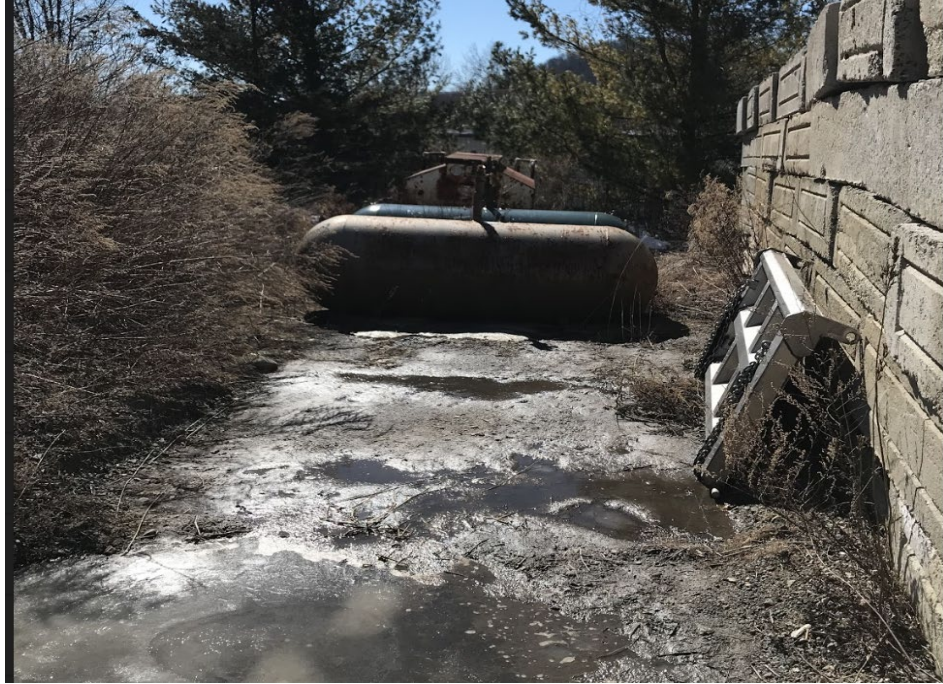
Photograph No 14. Former oil storage tanks on 20 Young's Field Road.

AOC-5: Take one grab sample underneath each tank, especially if staining is visible. Test for VOCs and petroleum hydrocarbons.
