GAP ANALYSIS FOR DEPARTMENT OF PUBLIC WORKS, NEW MILFORD, CT

Prepared for Brownfield Practicum

May 10th, 2021

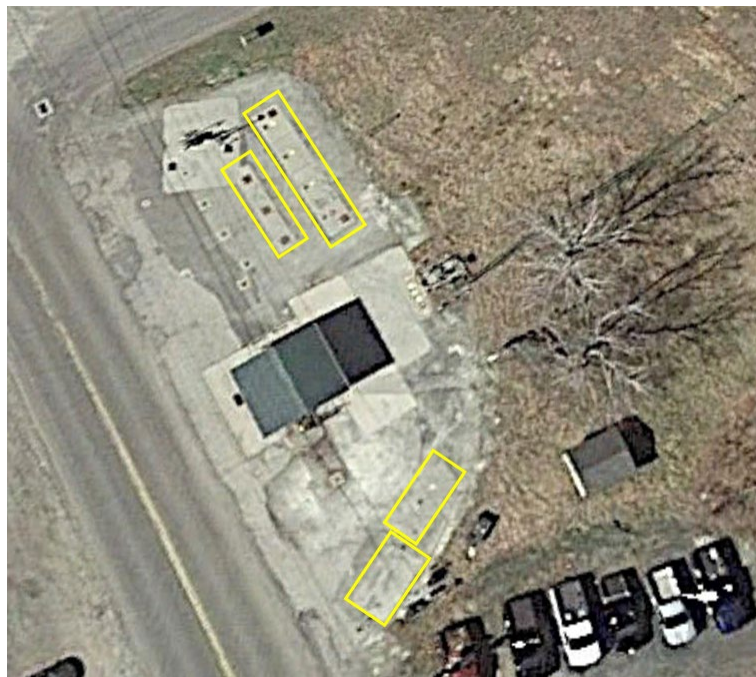
Figure 3. Current satellite image of 8 Young's Field Road outlining the location of the potential USTs.

Grab samples will be collected as part of the UST removal process according to the sampling protocols recommended by the CT Department of Energy and Environmental Protection (<https://portal.ct.gov/DEEP/Underground-Storage-Tanks/UST-Closure-Sampling-and-Analytical-Methods>). Samples will be collected from each of the tank's side walls and the soil directly underneath them. Twenty-two grab samples have been recommended for this site (see Figure 3).

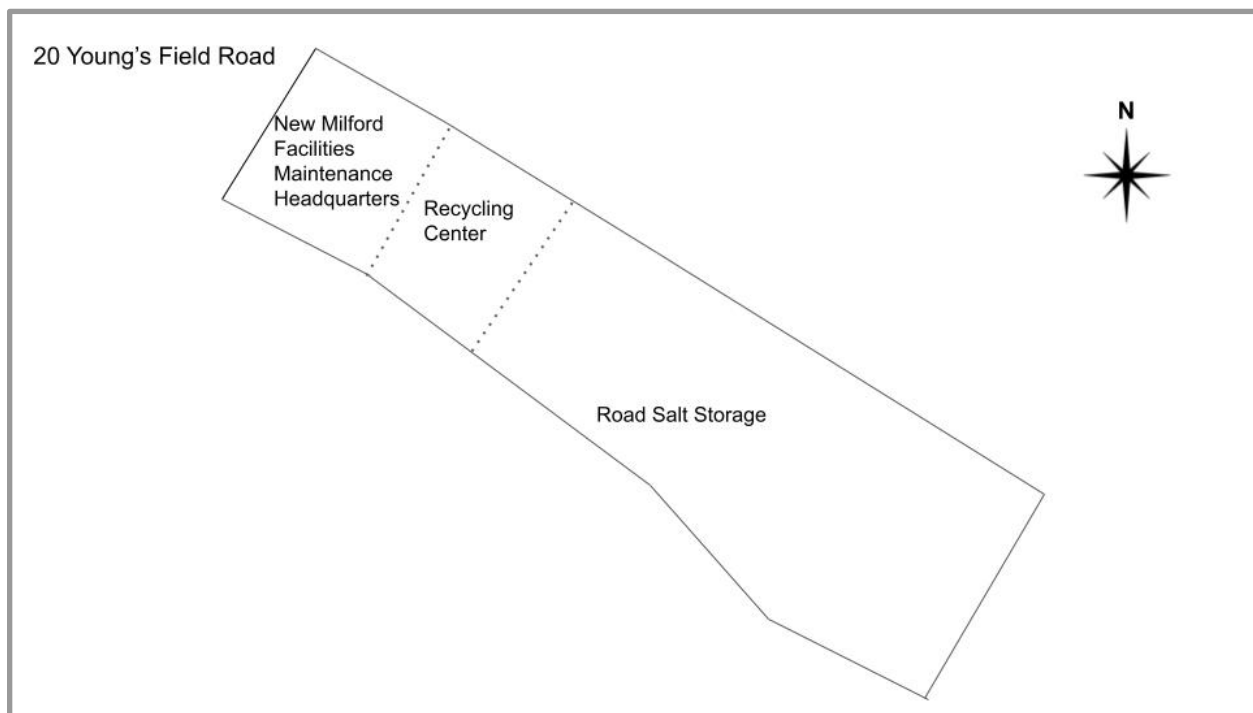
Figure 5. An overview of 20 Young's Field Road. Overviews of each of the three parcel segments are below.

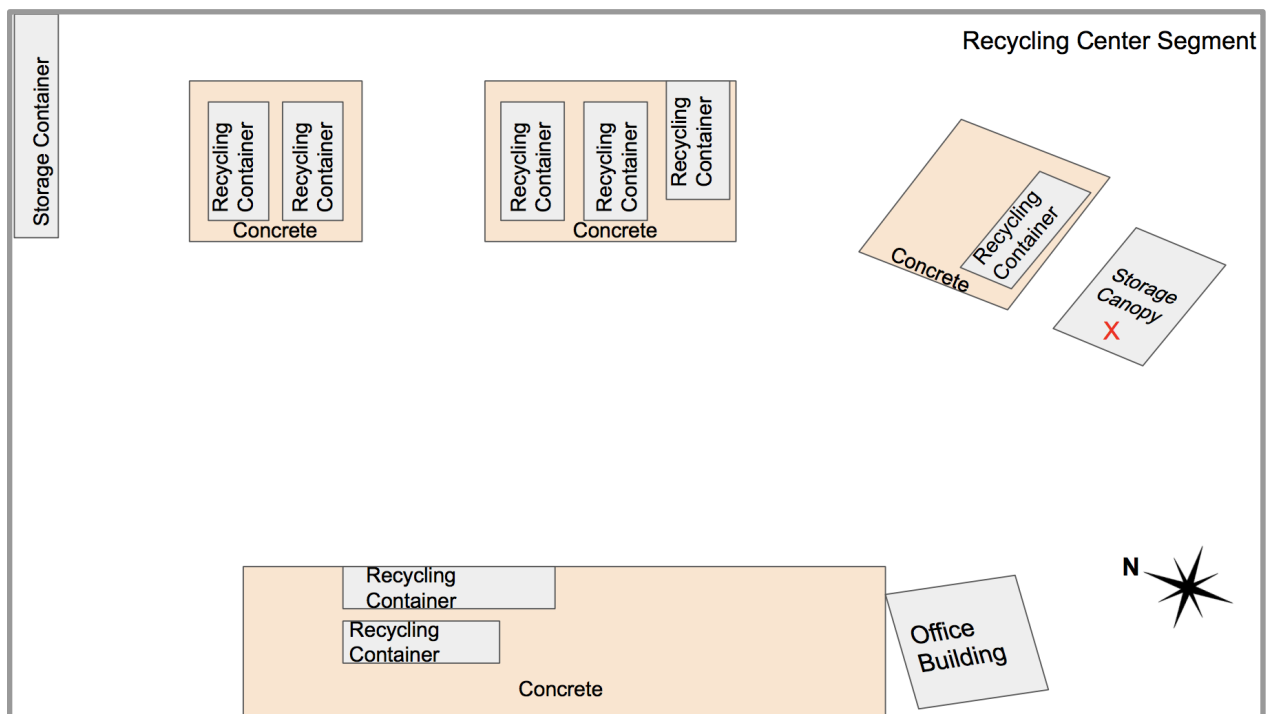
Figure 7. An overview of 20 Young's Field Road's recycling center segment.

The site visits showed several Areas of Concern with potential contamination that should be investigated as part of site redevelopment. Table 7 and Figures 7 and 8 summarize the recommending sampling for the identified areas.

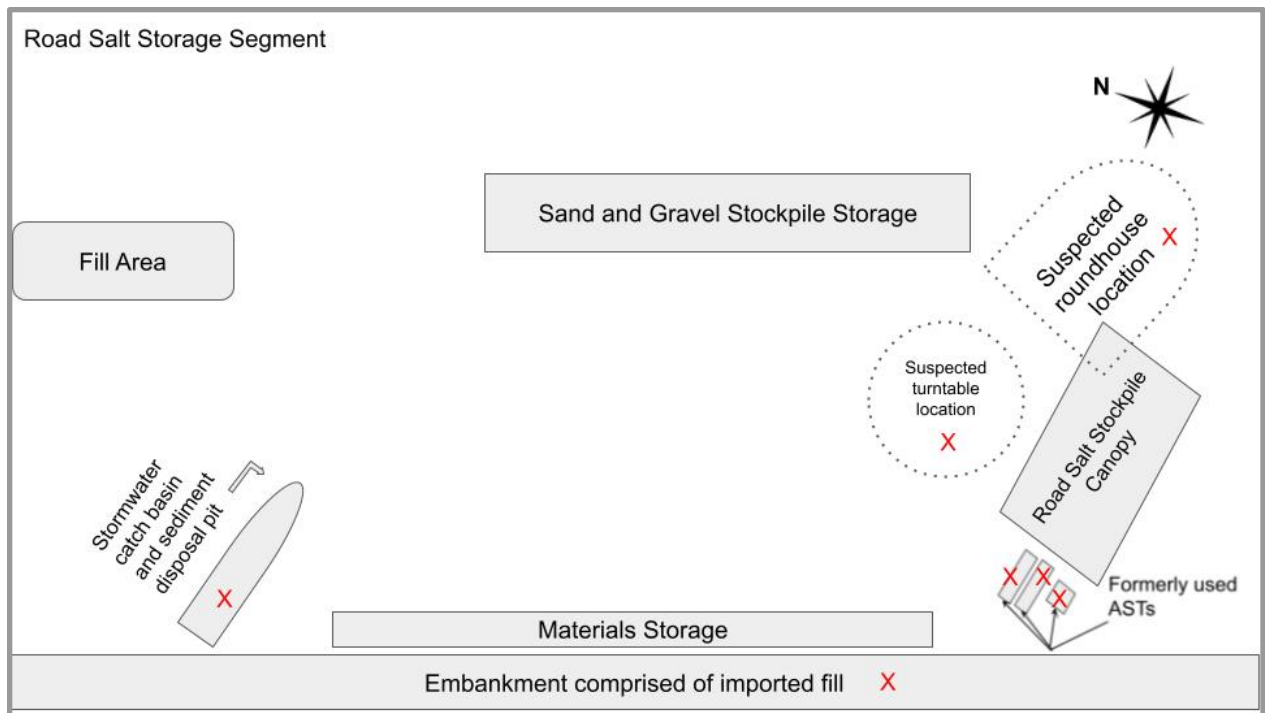
Figure 8. An overview of 20 Young's Field Road's road salt storage segment.

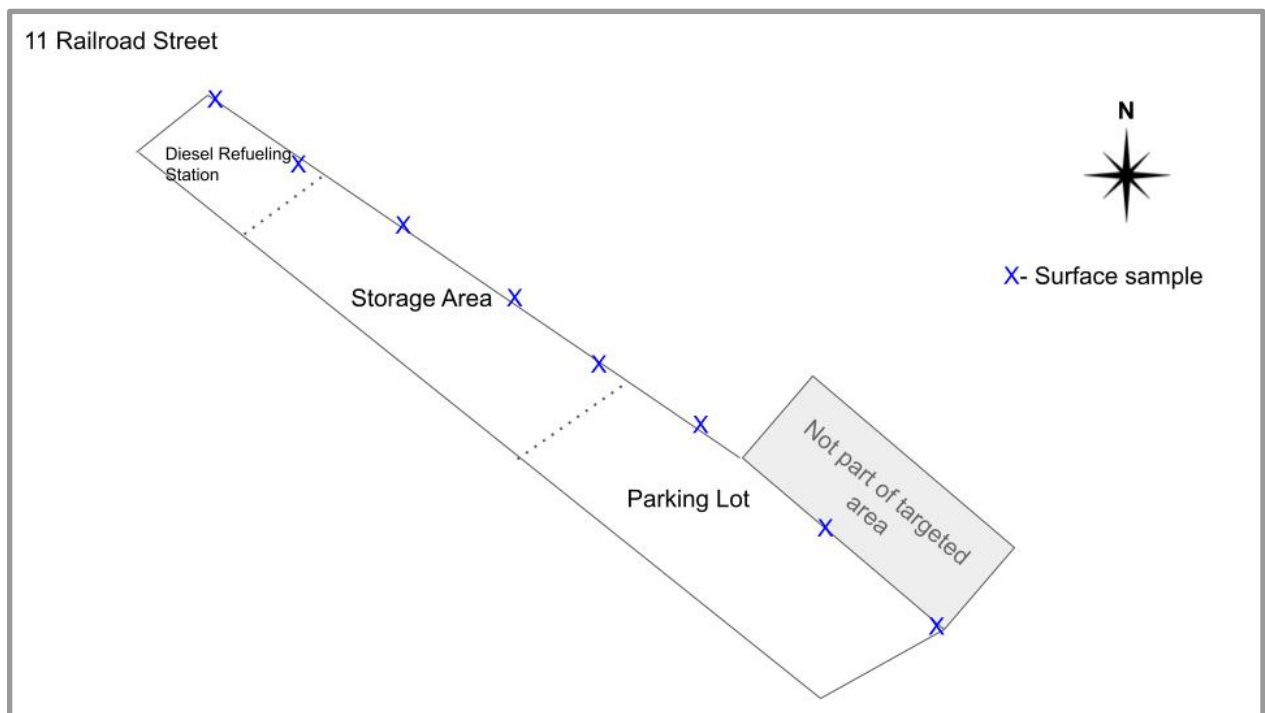
Figure 9. An overview of 11 Railroad Street. Overviews of the parcel's three segments are below.

It is recommended to take a sample in the area beneath the AST's pump to test for any possible spills via ETPH and VOCs (see Figure 9). A hand auger can be used to drill 5 ft below the surface.

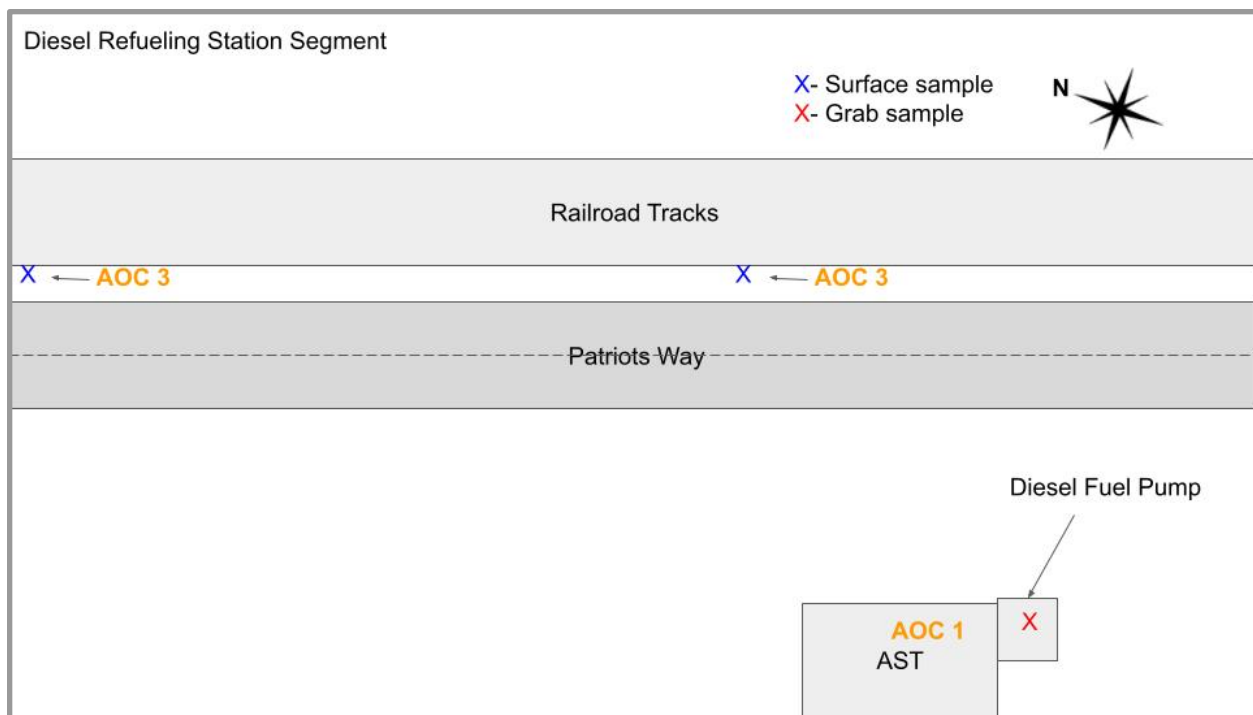
Figure 10. An overview of 11 Railroad Street's diesel refueling station segment.

Table 9 summarizes the recommended sampling plan to address the three AOCs, also shown in Figures 10 through 12.

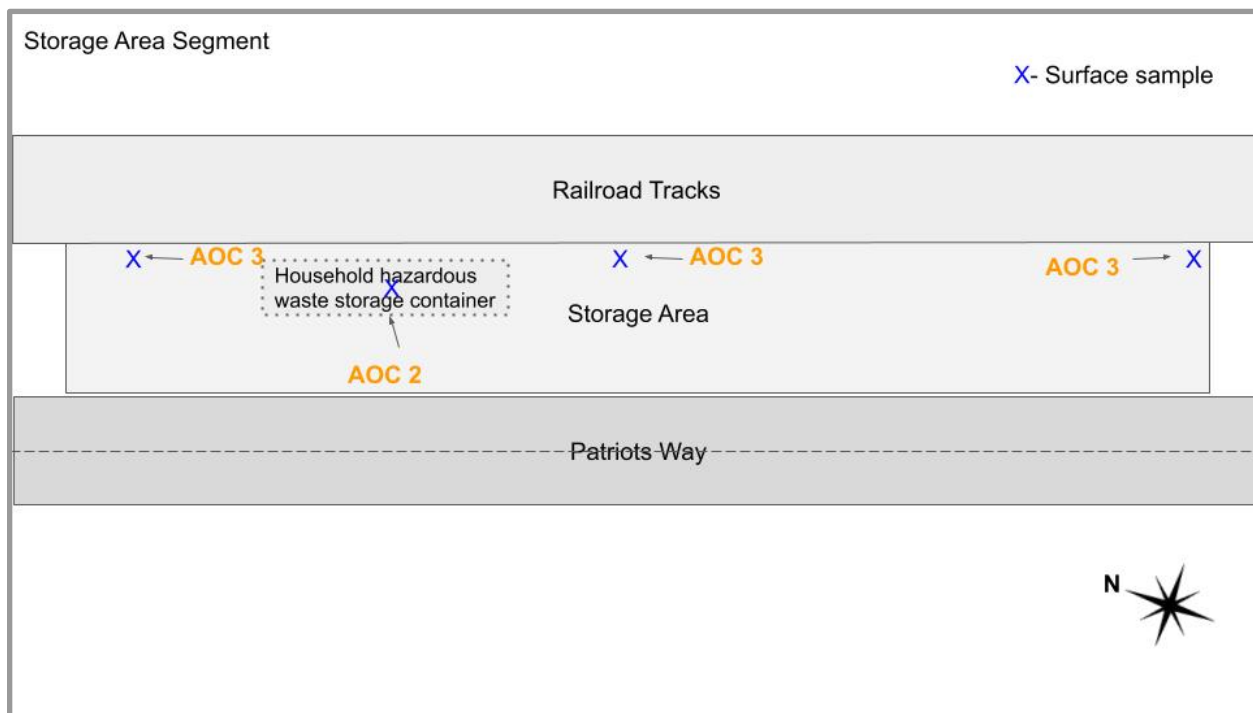
Figure 11. An overview of 11 Railroad Street's storage area segment.

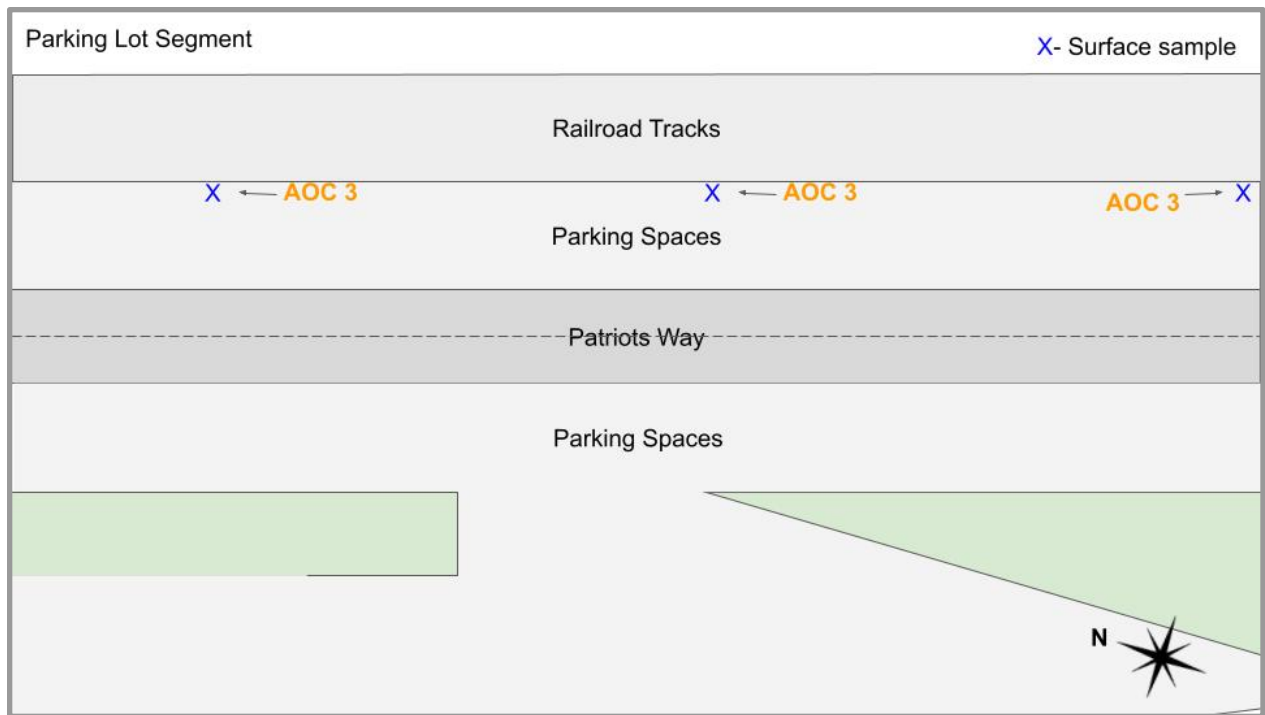
Figure 12. An overview of 11 Railroad Street's parking lot segment.

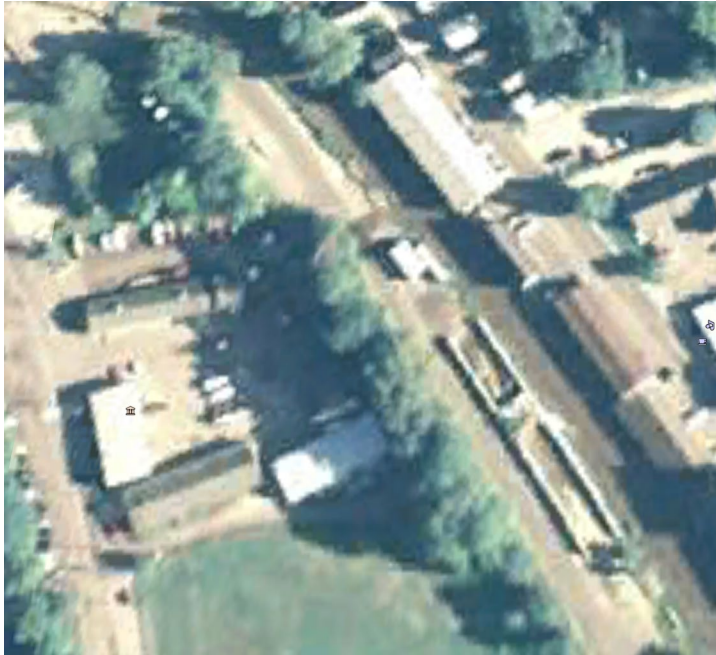
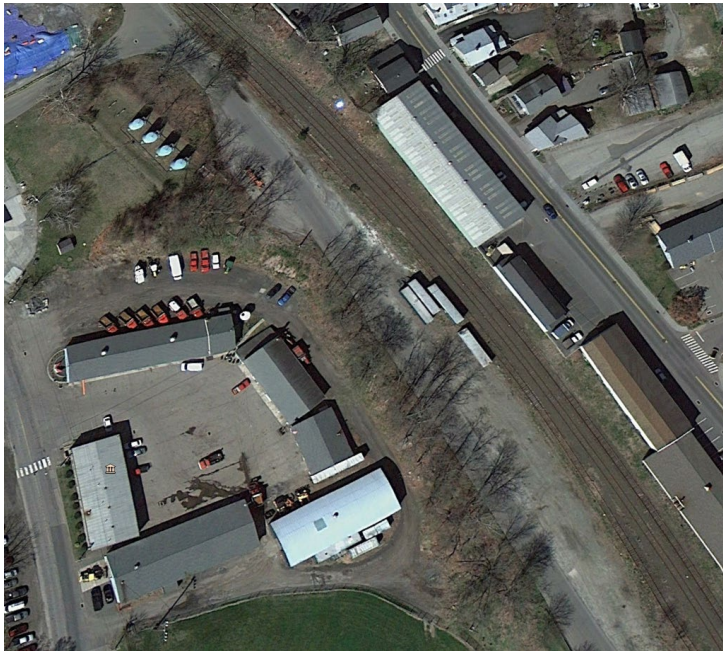
household hazardous waste was located in the northern portion of the parking lot and removed from the property, most likely between 2010 and 2012 based on Google Earth historical imagery (Image 5). The parking area has also been used to store plows, so that leaks and spills in the area may have occurred, according to DPW personnel.

Image 5. Google Earth view of parking lot area behind 6 YFR in 2010 (top) and 2012 (bottom)
